**Measurement of Airborne  
Sound Transmission Loss in  
Accordance with ASTM E90 of  
Classic 51 to 55 Panel  
Assemblies**

**B3504.1**

**Acoustic Measurements of Railtech Panel Assemblies**

**Skyfold Custom Powerlift Partitions, Railtech LTD.  
Montréal, Québec  
H9X 3S3**

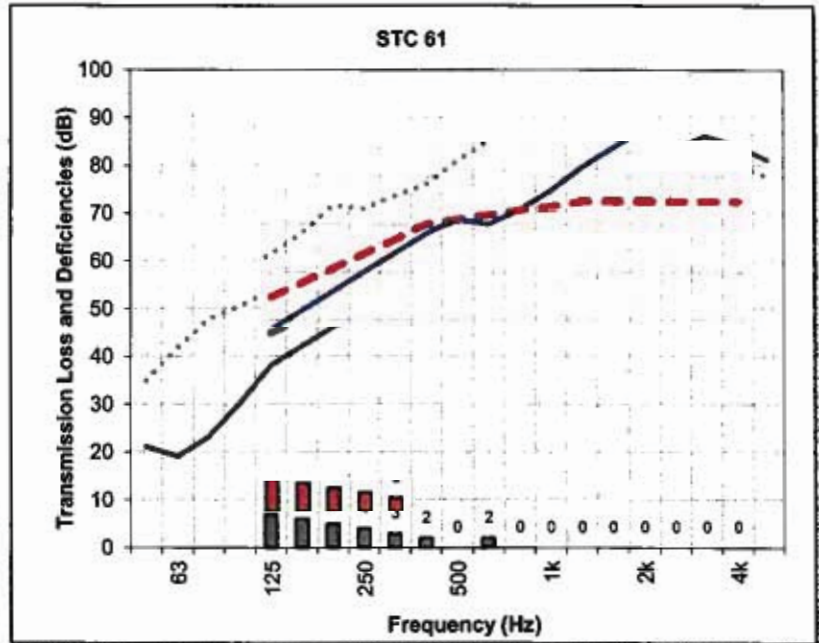
Frequency (Hz)	Airborne Sound Transmission Loss (dB)	95% Confidence Limits (dB)
50	21 *,clc	± 6.0
63	19 clc	± 4.3
80	23 clc	± 4.4
100	30 clc	± 3.9
125	38 clc	± 2.1
160	42 clc	± 2.6
200	46 clc	± 1.7
250	50 clc	± 1.5
315	54 clc	± 0.9
400	58 clc	± 0.8
500	61 clc	± 0.7
630	60	± 0.6
800	63	± 0.4
1000	67 clc	± 0.4
1250	72 clc	± 0.4
1600	76 c,clc	± 0.3
2000	80 c,clc	± 0.3
2500	83 c,clc	± 0.4
3150	86 *,min	± 0.4
4000	84 *,min	± 0.3
5000	81 *,min	± 0.5
Sound Transmission Class (STC) =		<b>61</b>

**In the graph:**

Solid line is the measured sound transmission loss for this specimen. Dashed line is the STC contour fitted to the measured values according to ASTM E413-04. The dotted line is 10 dB below the flanking limit established for this facility. Where measured transmission loss is above the dotted line, the reported value is potentially limited by vibration transmission via laboratory surfaces, and the true value may be higher than that measured. Bars at bottom of graph show deficiencies. At each frequency the difference between the shifted reference contour value and the measured data is calculated. Only deficiencies, that is, where the measured data are less than the reference contour, are counted in the fitting procedure for the STC, defined in ASTM E413-04.

**In the table:**

Values marked "c" indicate that the measured background level was between 5 dB and 10 dB below the combined receiving room level and background level. The reported values have been corrected according to the procedure outlined in ASTM E90-09.

Values marked "\*" indicate that the measured background level was less than 5 dB below the combined receiving room level and background level. The reported values provide an estimate of the lower limit of airborne sound transmission loss.

Values marked with "clc" indicate a correction applied for transmission that occurs through the filler wall.

Values marked "min" indicate transmission through the filler wall was within 6 dB.
